Report on the investigation of the  
keel failure, capsized, and loss of one crew member from  
the Max Fun 35 yacht

***Hooligan V***

Marine Accident Investigation Branch  
Carlton House  
Carlton Place  
Southampton  
United Kingdom  
SO15 2DZ

**Report No 19/2007  
August 2007**

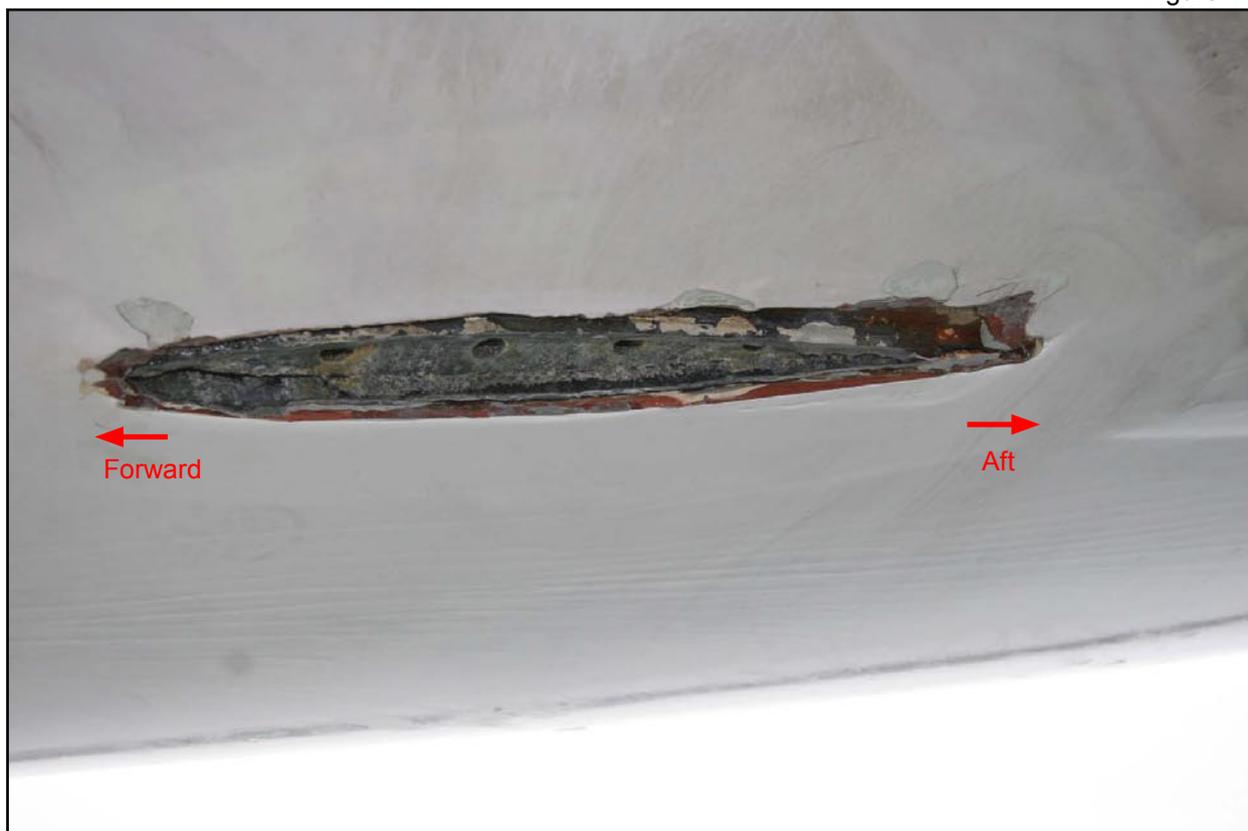
Figure 10

The keel was found to have been detached just below the fillet weld which had secured the fin to the taper box (**Figure 10**). The presence of “beach marks” (**Figure 11**) on the fracture surface suggested that the fin had become detached through a mechanism of fatigue failure. There was also evidence of corrosion around the area of the weld.

Remains of fin, showing point of detachment

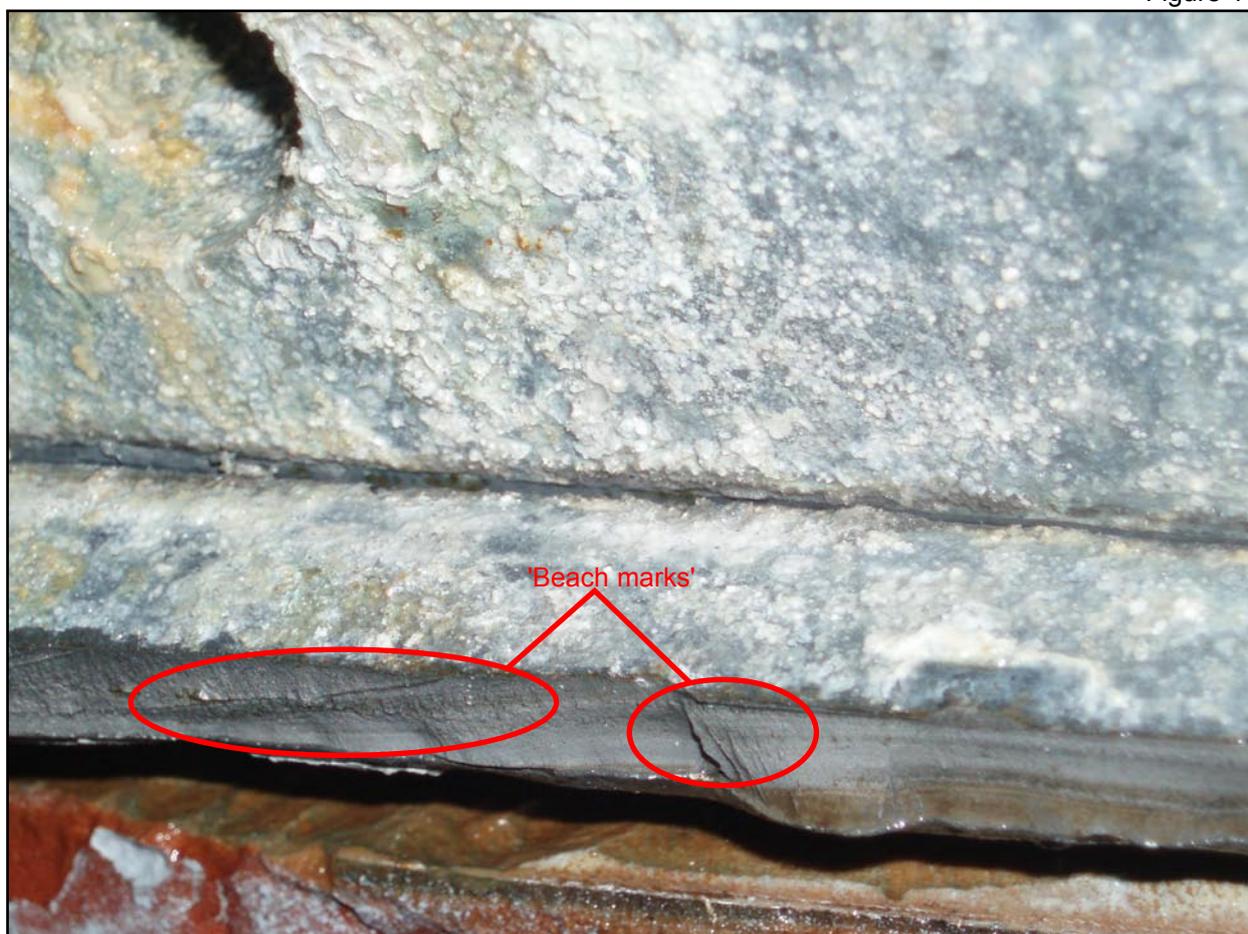
Figure 11

Remains of fin, showing 'beach marks'

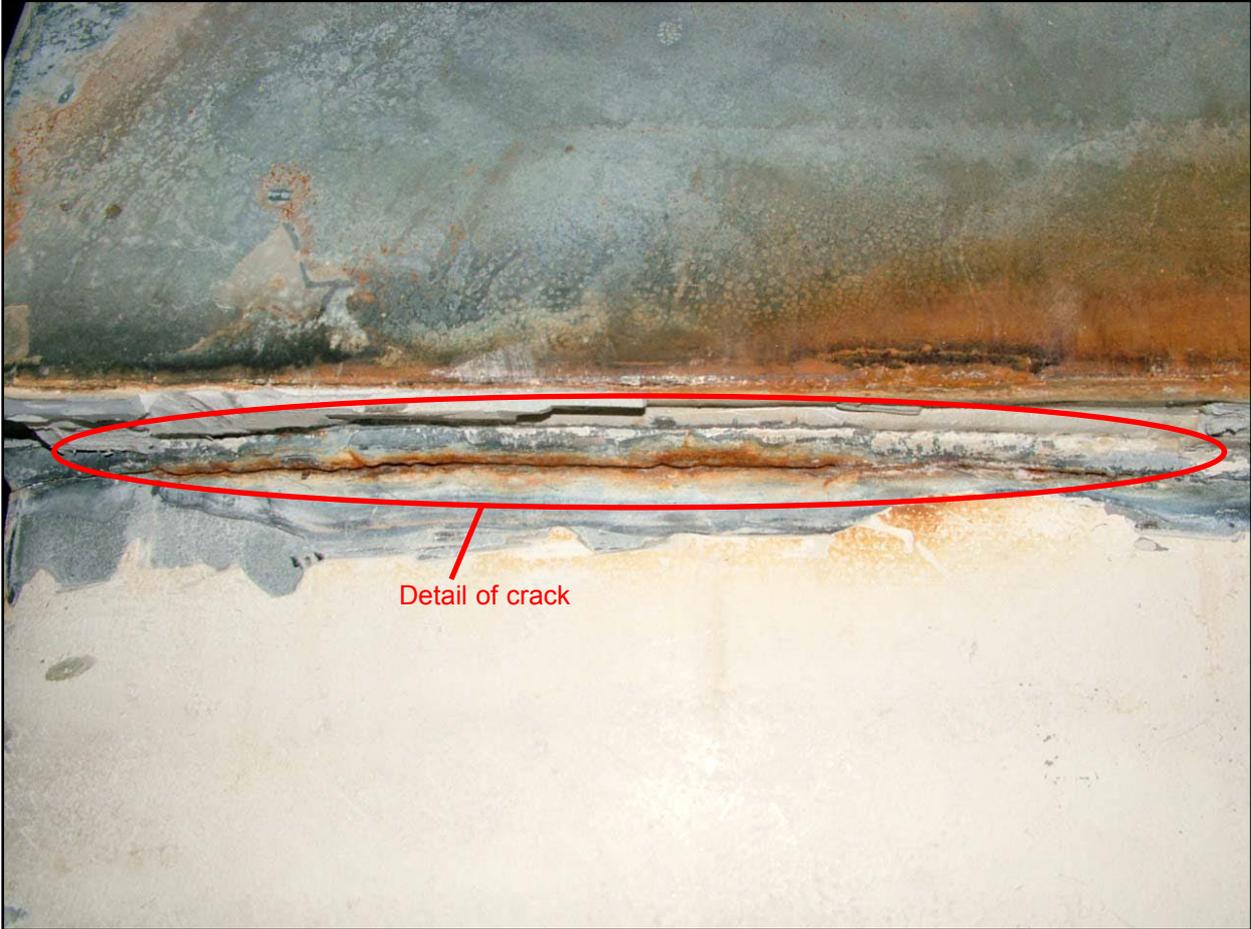
Figure 26

In March 2007 the owner was concerned that one of these boats, *Who Cares*, was not in an upright position when alongside the pontoon. The boat was taken out of the water and it was found that the keel fin had suffered a 370mm fracture along the port side directly under the fillet weld connecting the fin to the taper box (**Figures 25 and 26**).

Detail of the fracture to the port side of the keel fitted to *Who Cares*

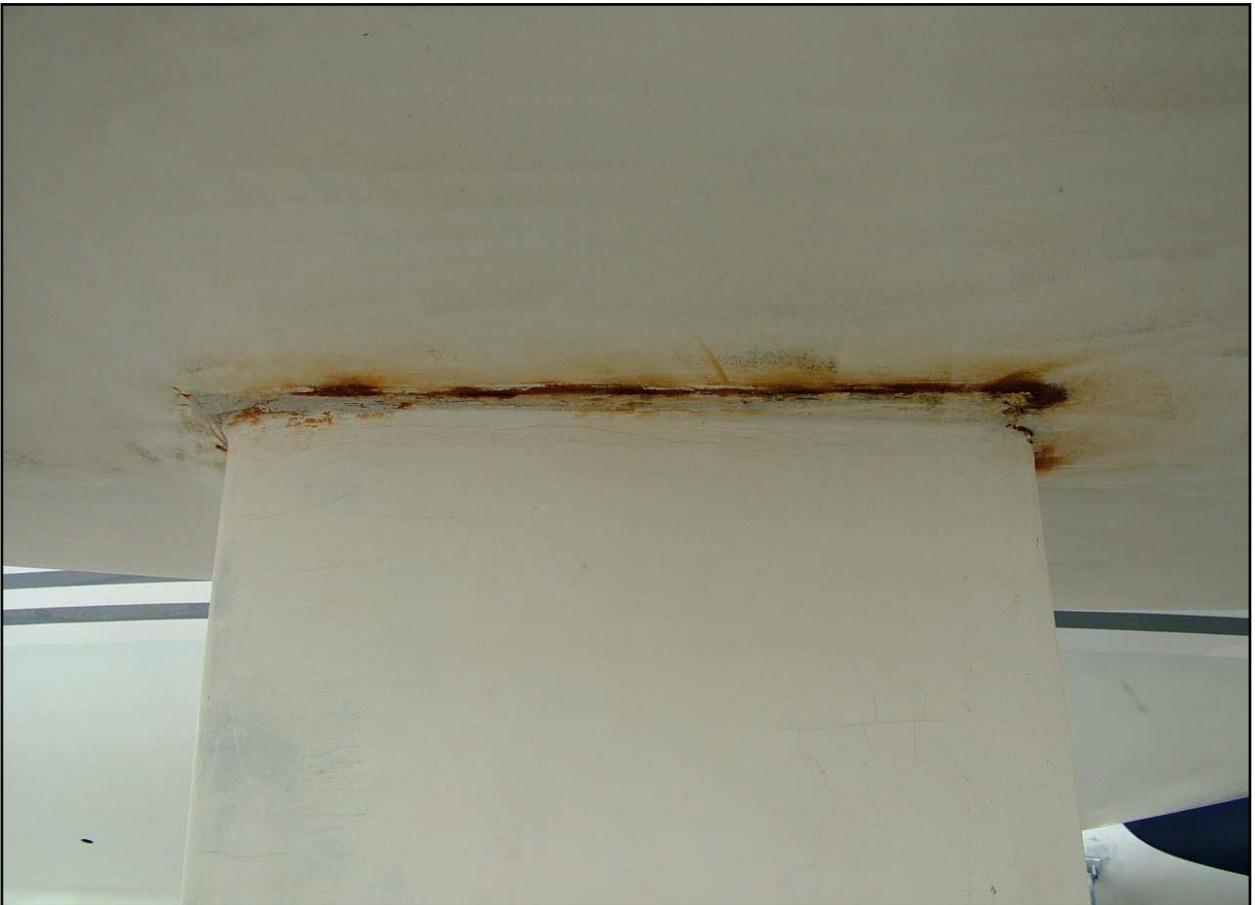
Figure 28

The keels of two other Max Fun 35s, *Mad Max* and *Guts "n" Glory* (**Figures 28 and 29**) were also visually examined. Both exhibited movement of the keel, evidenced by cracking of the epoxy fillers and anti-fouling surfaces. The condition of the steel keel structures has not been determined.

Keel of *Mad Max* showing cracking of the epoxy fillers and anti-fouling
