Report on the investigation of
a fatal man overboard from the Reflex 38 yacht
Lion

14.5 miles south of Selsey Bill, West Sussex

18 June 2011

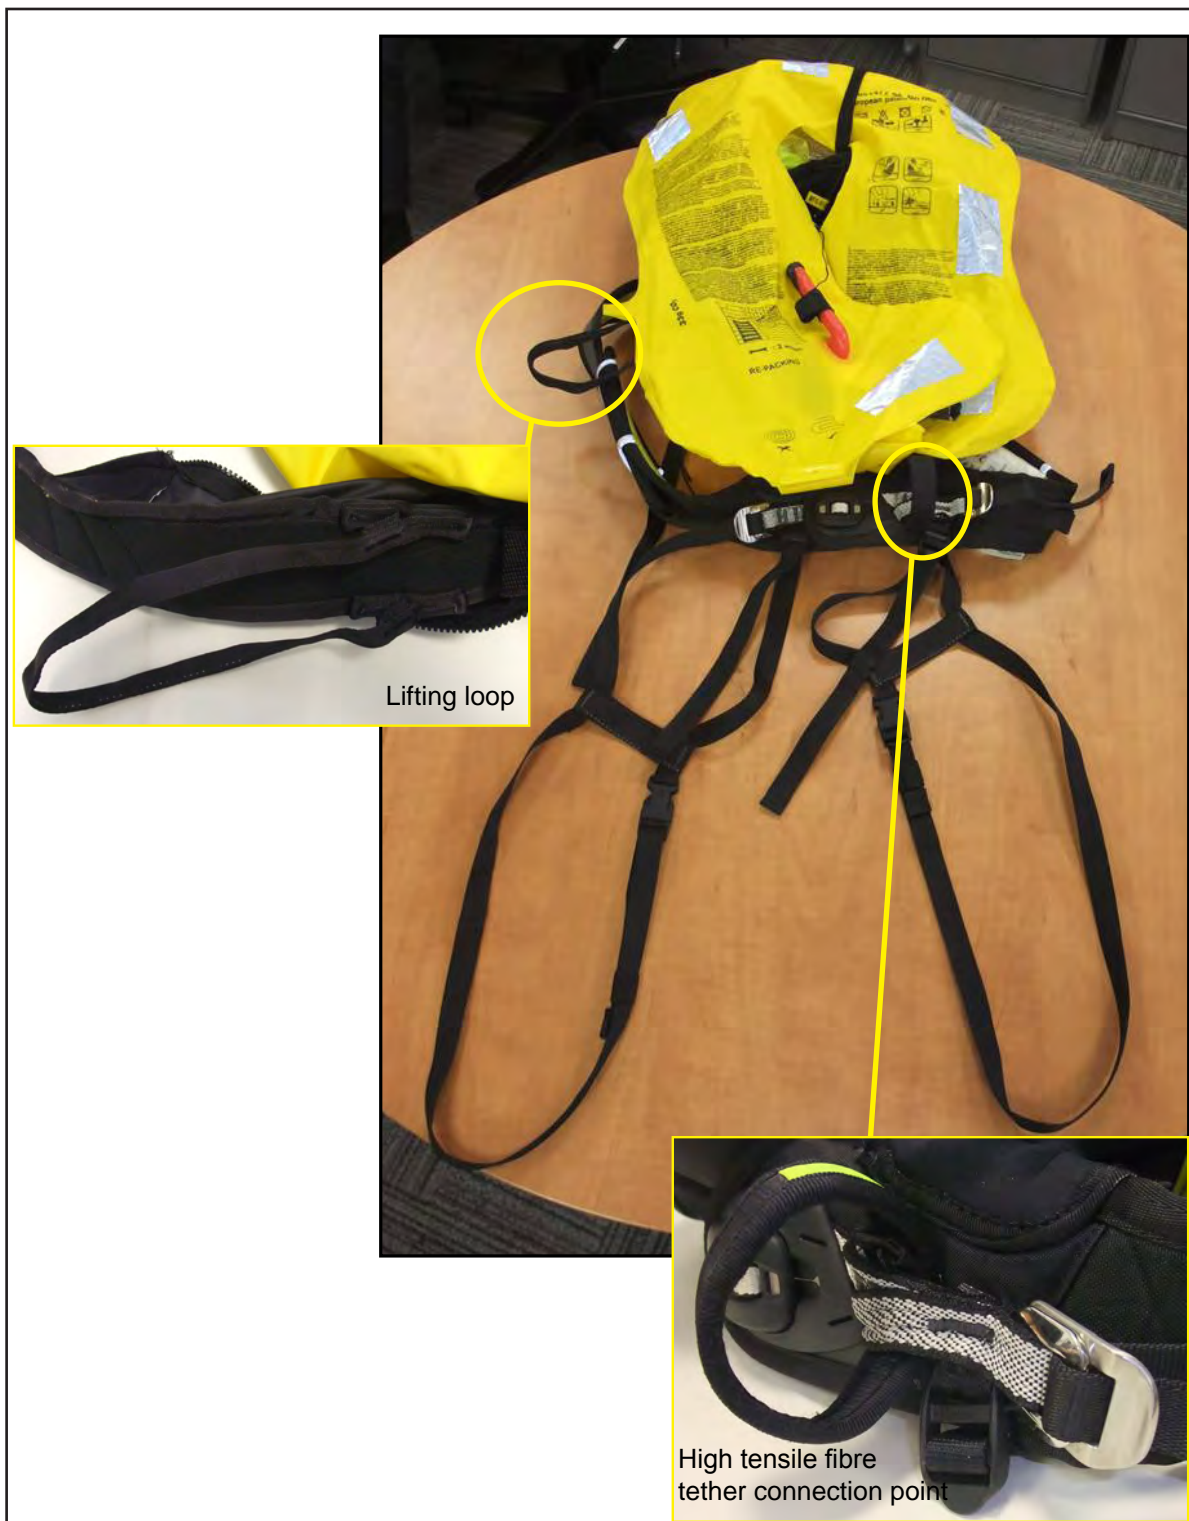
Figure 12: Skipper's Spinlock Deckvest 150 Pro Sensor lifejacket, harness and thigh straps

On inspection following the accident, the lifejacket, harness and thigh straps were found to be in good condition with no obvious damage to their components. The arrangement is shown at **Figures 12** and **13**.
