Report on the investigation of
two serious injuries on board
the IMX 38 yacht

Roaring Meg of Cowes

on 20 May 2006

Report No 29/2006
November 2006

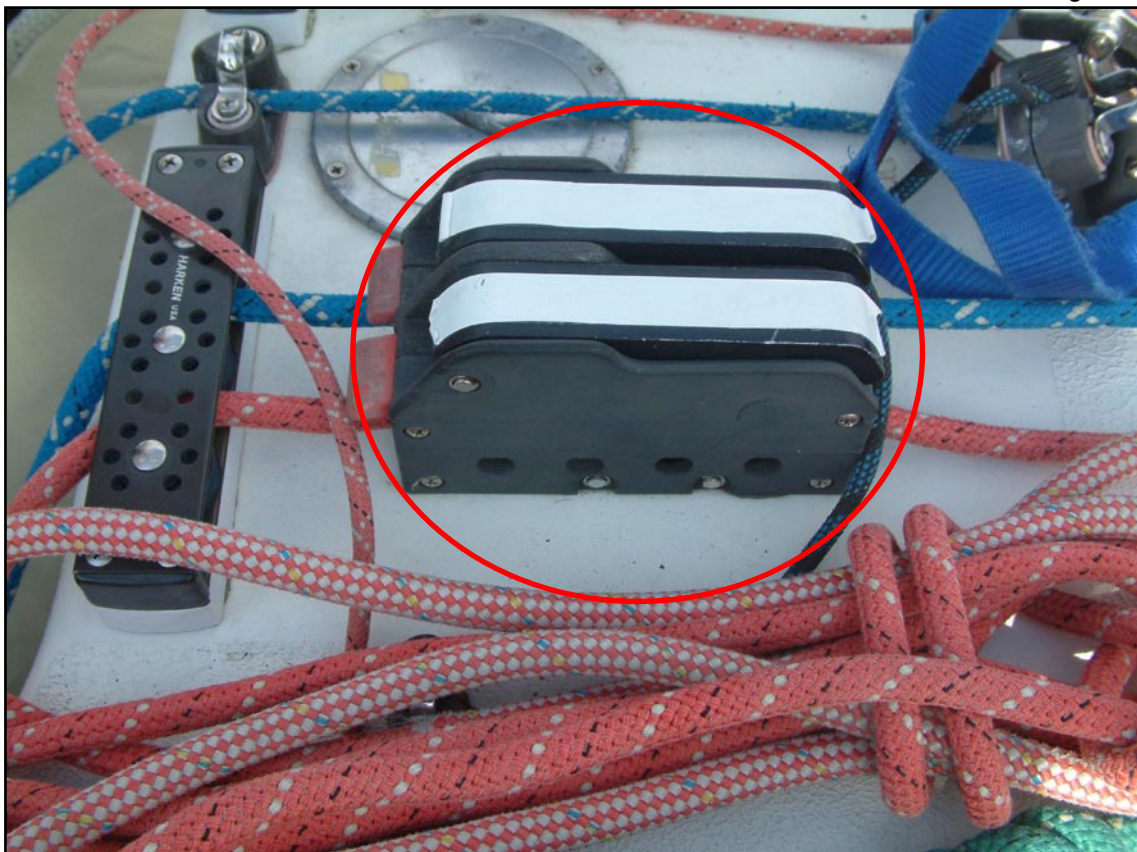
Figure 2

At about 1000, it had started to rain as the replacement skipper arranged for the group to rig the single reefed mainsail and the genoa. He indicated that probably only the genoa would be used because of the wind conditions on Southampton Water. The mainsail repeatedly jammed in the boom track, but it was eventually rigged and secured to the boom with ties. Some of the group also noticed that several of the jamming cleats on top of the coach roof were very difficult to operate, and failed to “lock off” effectively allowing the rope to be pulled through the cleat. Despite identifying labels being affixed to the cleats, the text had been abraded, so the group were unable to identify the purpose of individual ropes or cleats (**Figure 2**).

Locking cleat and worn identification label

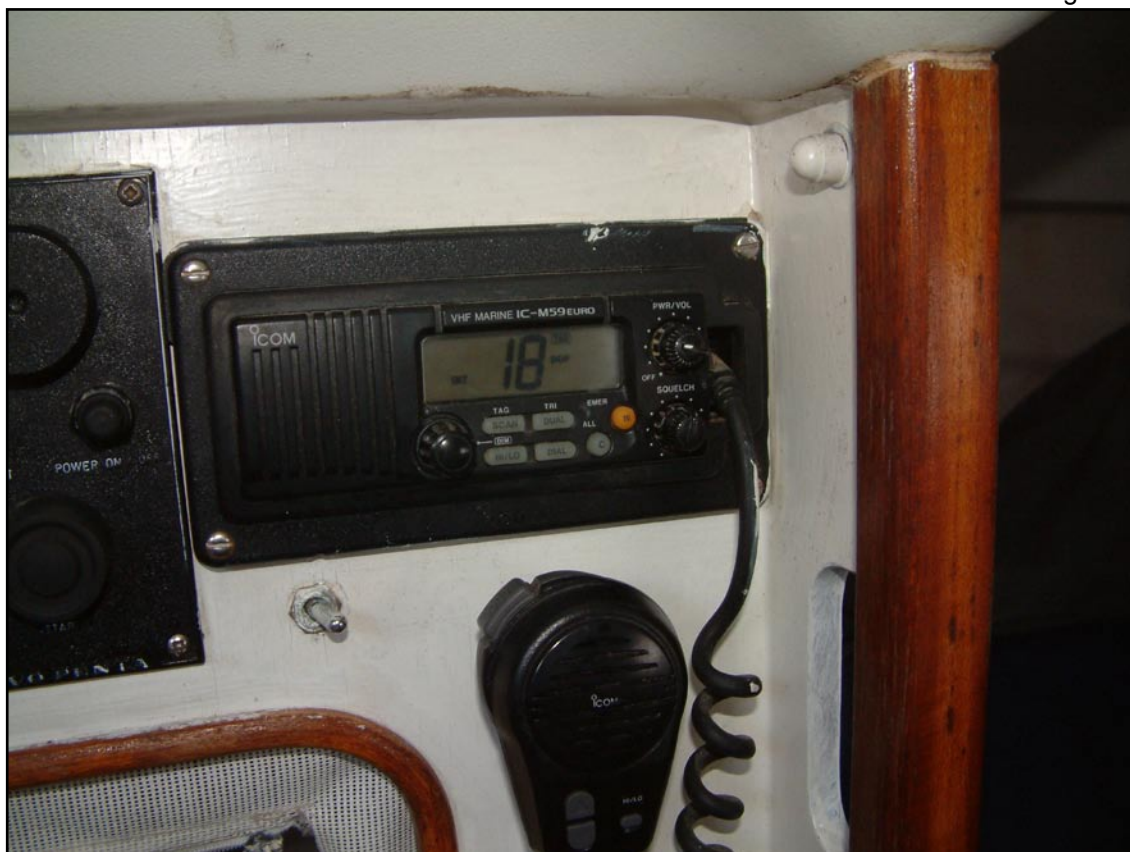
Figure 4

The skipper then briefly described the sailing rig, tacking procedure, use of the traveller rig, and the purpose of the various ropes and the warnings to be given prior to tacking the yacht. He described the mainsheet winch operation and how to "lock off" the ropes, although some of the group had difficulty in doing this. He then allocated the group their various tasks. The group's day skipper then went down below to familiarise himself with the yacht's layout. He checked the fuel gauge, engine starting controls and found the VHF radio (**Figure 4**), which was switched off. The day skipper switched the radio on, but at no time did the replacement skipper carry out any checks on the radio.

ICOM Marine IC M-59 VHF radio

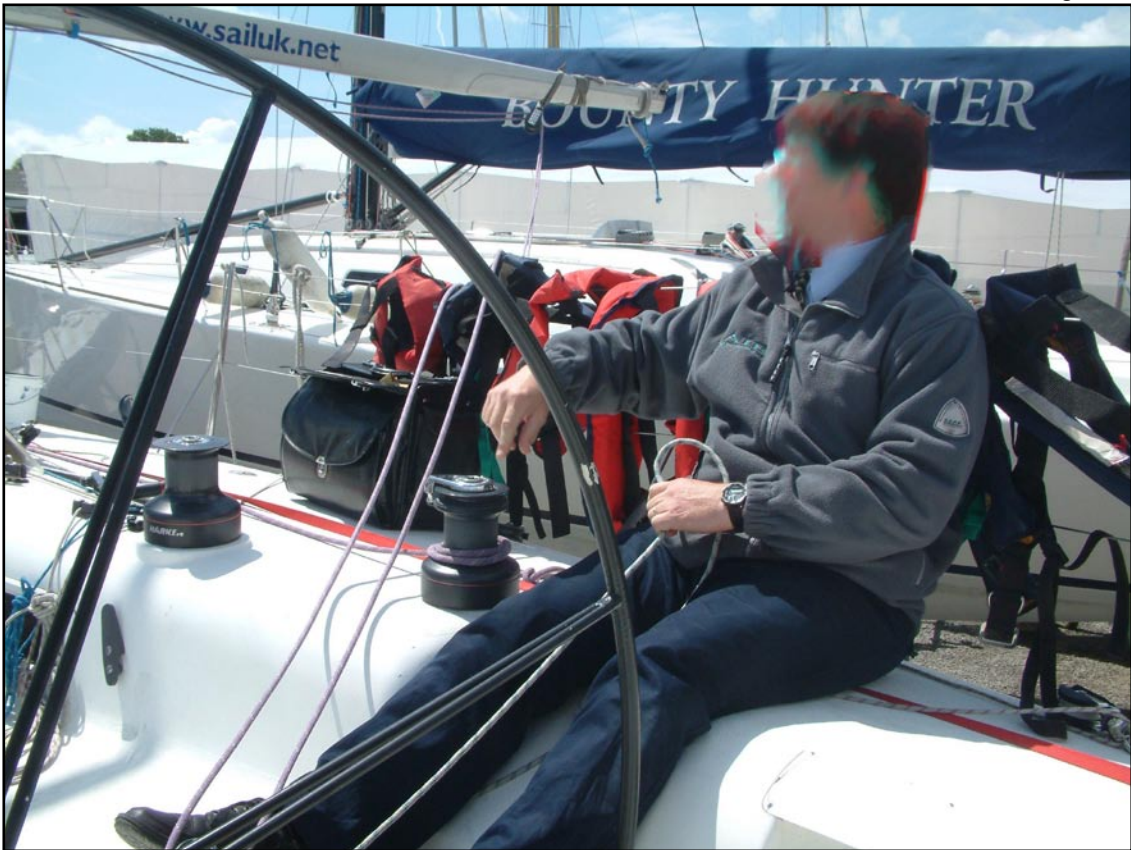
Figure 6

The earlier concerns of most of the group faded as the yacht moved into Southampton Water, and they settled down to the business of sailing. The group conducted a series of tacks, making between 5 and 6 knots towards Southampton Docks. Their confidence grew, and some opted to change positions, as suggested by the replacement skipper. The exception was the lady who was to suffer the serious head injury. She had been efficiently operating the traveller rig under the direct instruction of the replacement skipper, and remained in that position throughout (**Figure 6**).

Traveller operating position

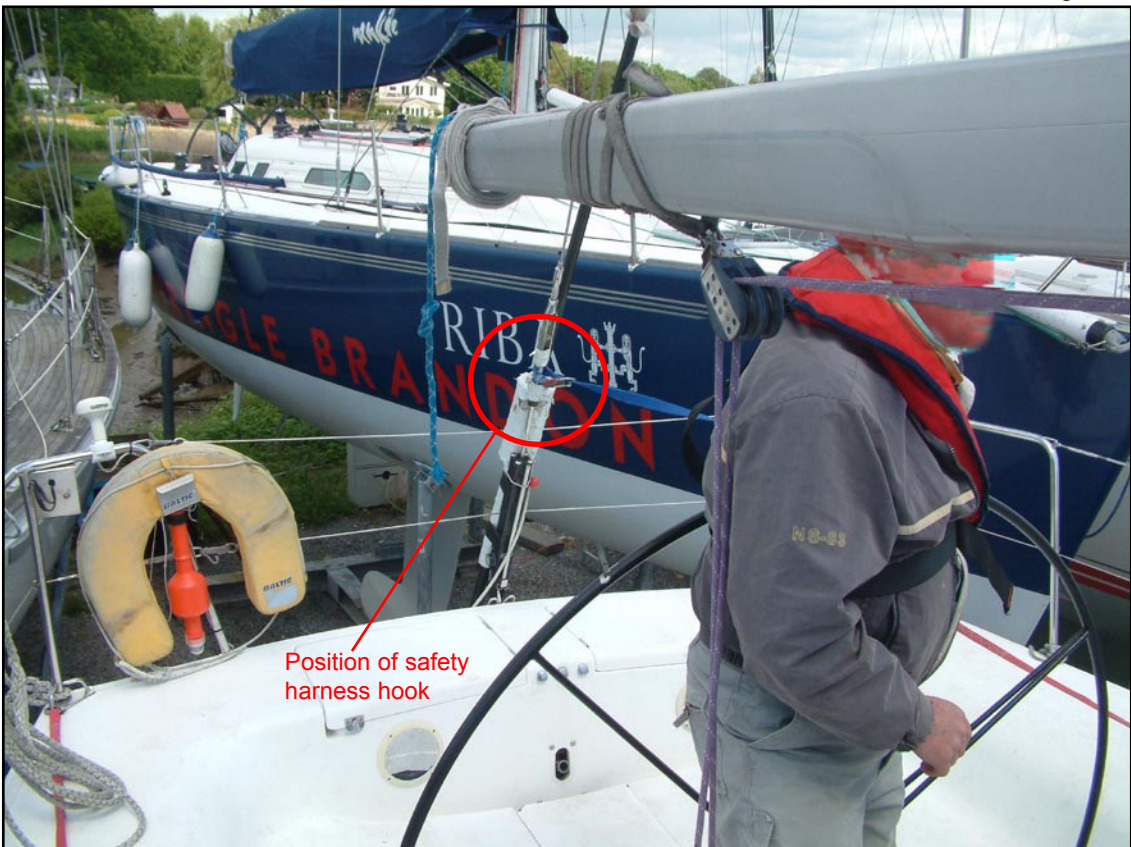
Figure 7

A light lunch was made at about 1320. The group's day skipper then asked if he could take the helm. The skipper was grateful because he was suffering from back pain following a recent Atlantic crossing in a yacht. The day skipper clipped his personal safety harness to the rod backstay situated behind the wheel at the transom (**Figure 7**).

Position of day skipper's safety harness on rod backstay

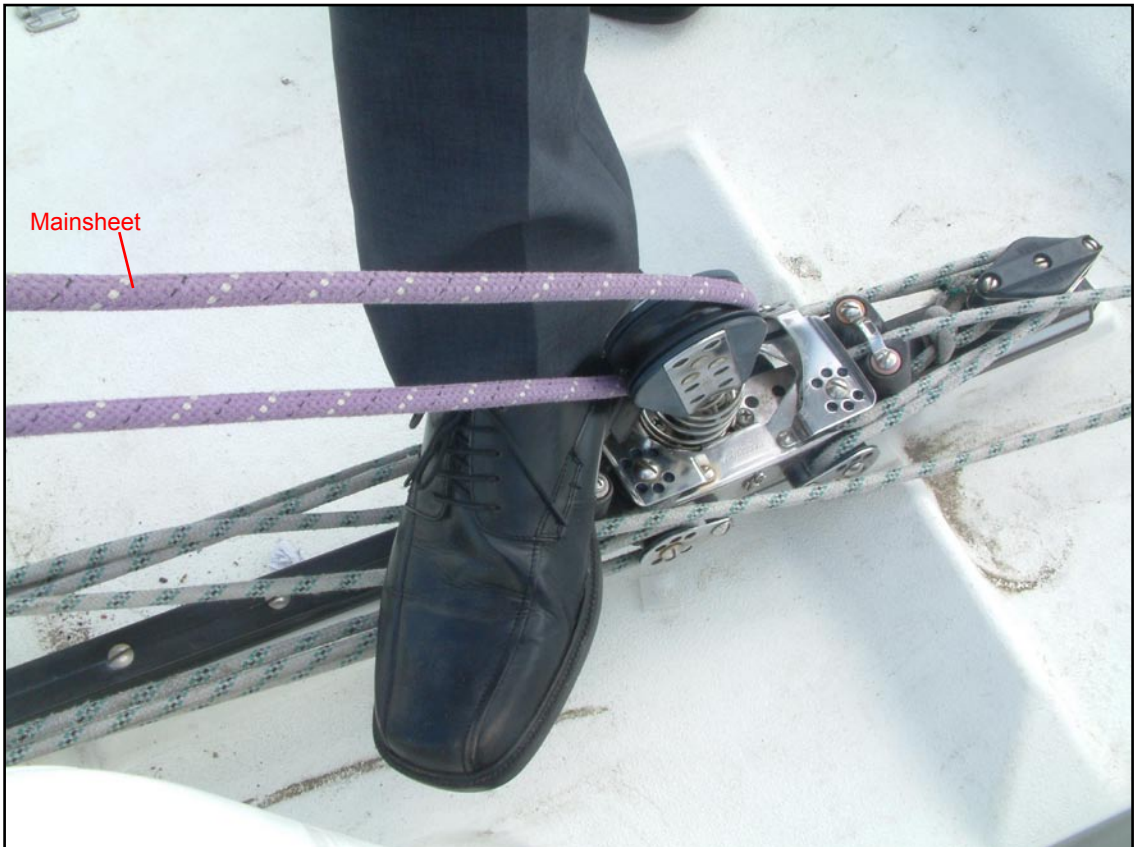
Figure 9

Day skipper's leg position on the traveller rig

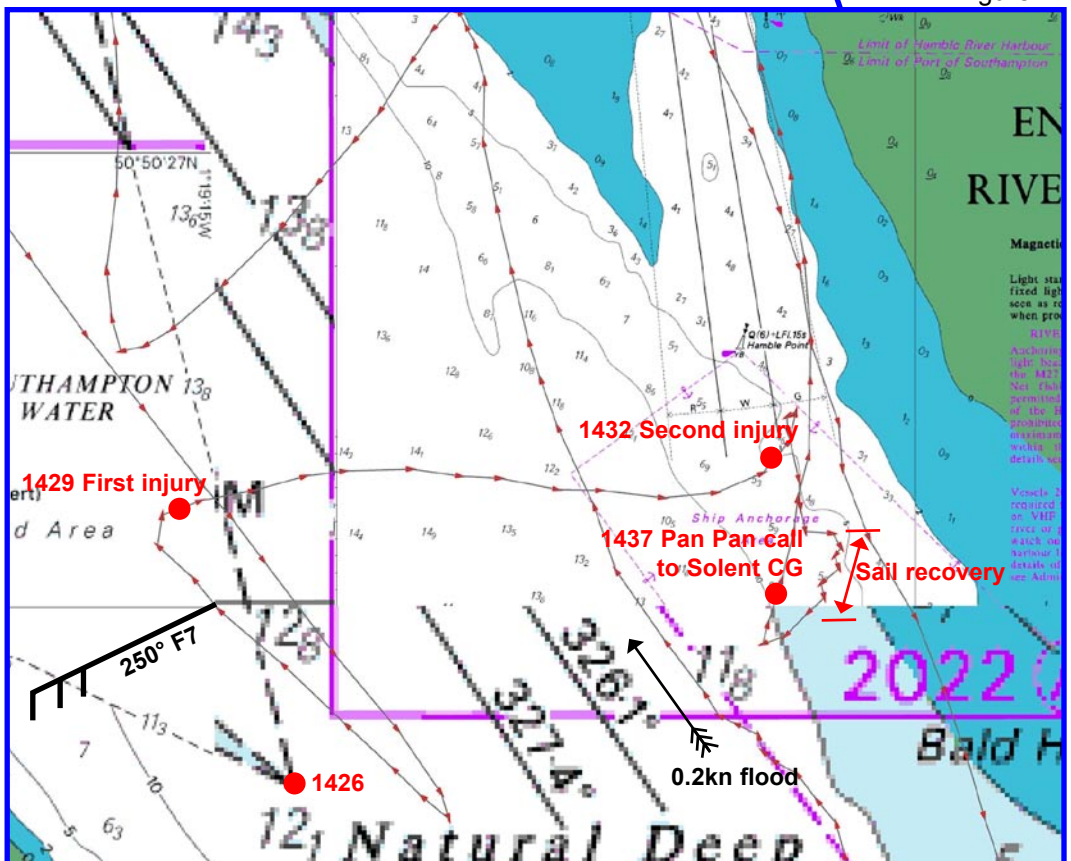
Figure 11

Detailed GPS track - showing key accident points

The GPS track, at **Figure 11**, shows that the yacht completed her south-easterly run at 1426. At this time, the replacement skipper elected to tack back up Southampton Water. Having moved onto a port tack, he sailed approximately NW for about 2 minutes, before bearing away close to the oil jetties on the west side of Southampton Water. The first accident happened almost immediately afterwards.

As the day skipper went to start the engine, his safety harness became taut against the wheel. The skipper then became distracted by having to turn around to unclip the day skipper's harness. As a result, the yacht began to run by the lee and made an involuntary gybe onto a starboard tack resulting in the day skipper's injuries. Immediately after, the boom swung back to starboard and the yacht returned onto a port tack. It is possible that the day skipper's taut harness moved the wheel and contributed to the gybe, especially as the replacement skipper had to use both hands to release the harness. However, neither the replacement skipper, nor any of the group can confidently recall whether this happened.
