Report on the investigation of
a fatal man overboard from the Reflex 38 yacht
Lion

14.5 miles south of Selsey Bill, West Sussex

18 June 2011

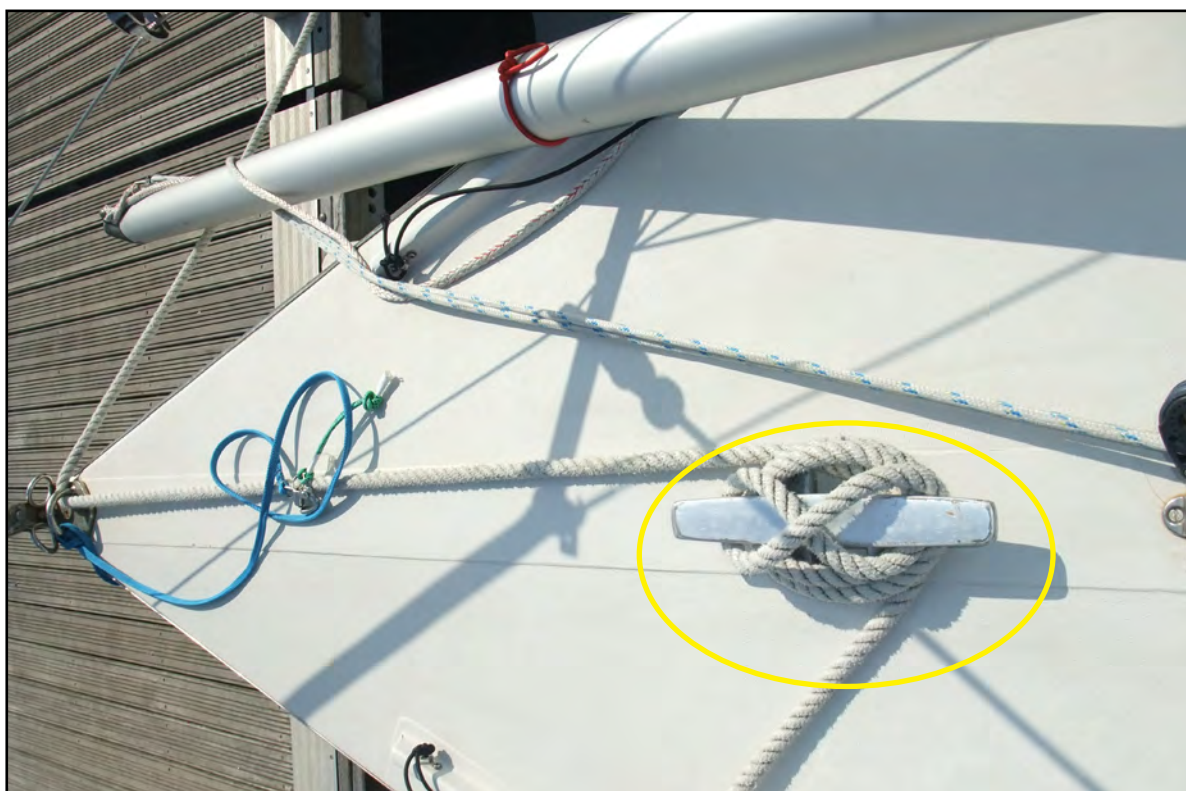
Figure 5: Position of the forward centreline cleat

As the skipper recovered the sail from the water it was passed along the starboard side by trimmers 1 and 2, and the navigator guided it down the companionway and into the cabin. When all of the sail was recovered on board, the skipper disconnected the tack from the forward pad eye. He then transferred his tether from the port to the starboard jackline in preparation to return to the cockpit along the high, starboard side, as was his usual practice. Almost immediately, the sail snagged and the skipper called “stop”. Trimmer 1 then saw him lie on the deck, on his stomach, facing forward and to starboard of the centreline. It is likely that the sail had snagged on the forward centreline cleat (**Figure 5**) and the skipper was attempting to free it. After a short time, the skipper called “OK” and the sail continued to be passed along the starboard side, partly over the coach roof and down the companionway into the cabin.
