Report on the investigation of
two serious injuries on board
the IMX 38 yacht

Roaring Meg of Cowes

on 20 May 2006

Report No 29/2006
November 2006

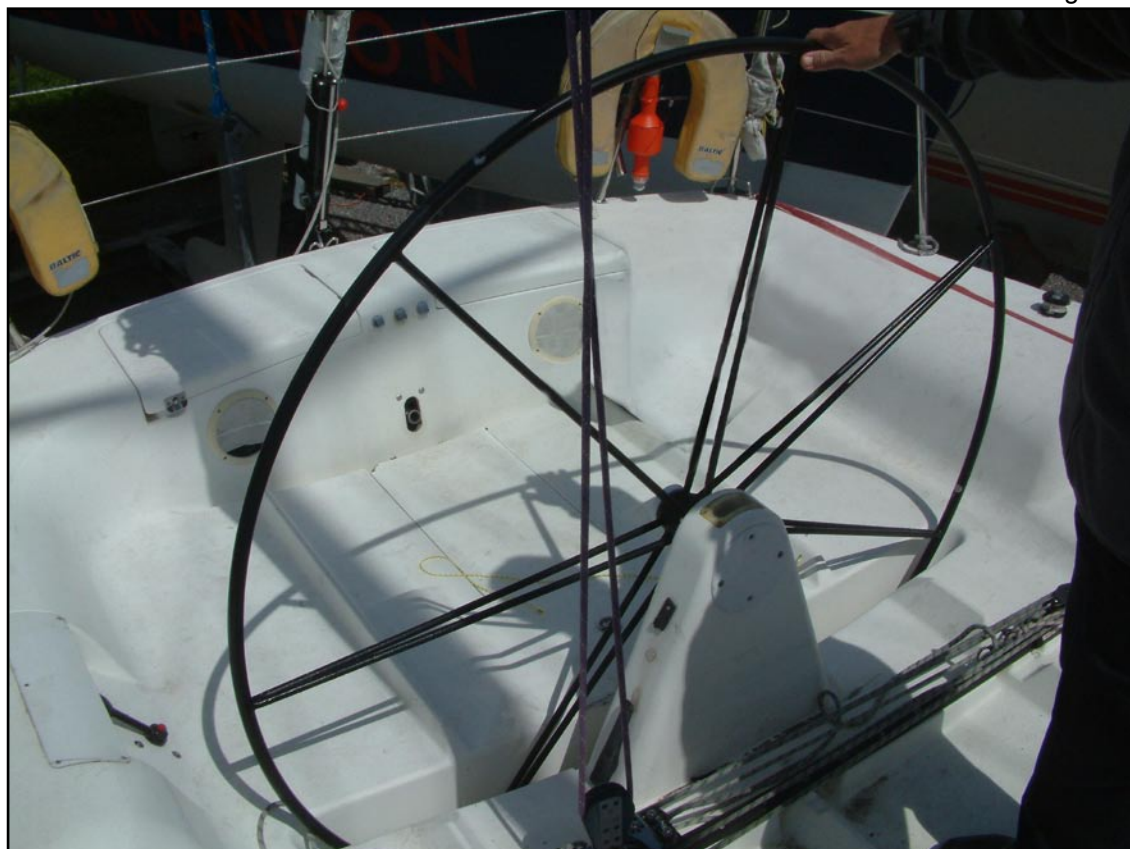
Figure 6

The earlier concerns of most of the group faded as the yacht moved into Southampton Water, and they settled down to the business of sailing. The group conducted a series of tacks, making between 5 and 6 knots towards Southampton Docks. Their confidence grew, and some opted to change positions, as suggested by the replacement skipper. The exception was the lady who was to suffer the serious head injury. She had been efficiently operating the traveller rig under the direct instruction of the replacement skipper, and remained in that position throughout (**Figure 6**).

Wheel position

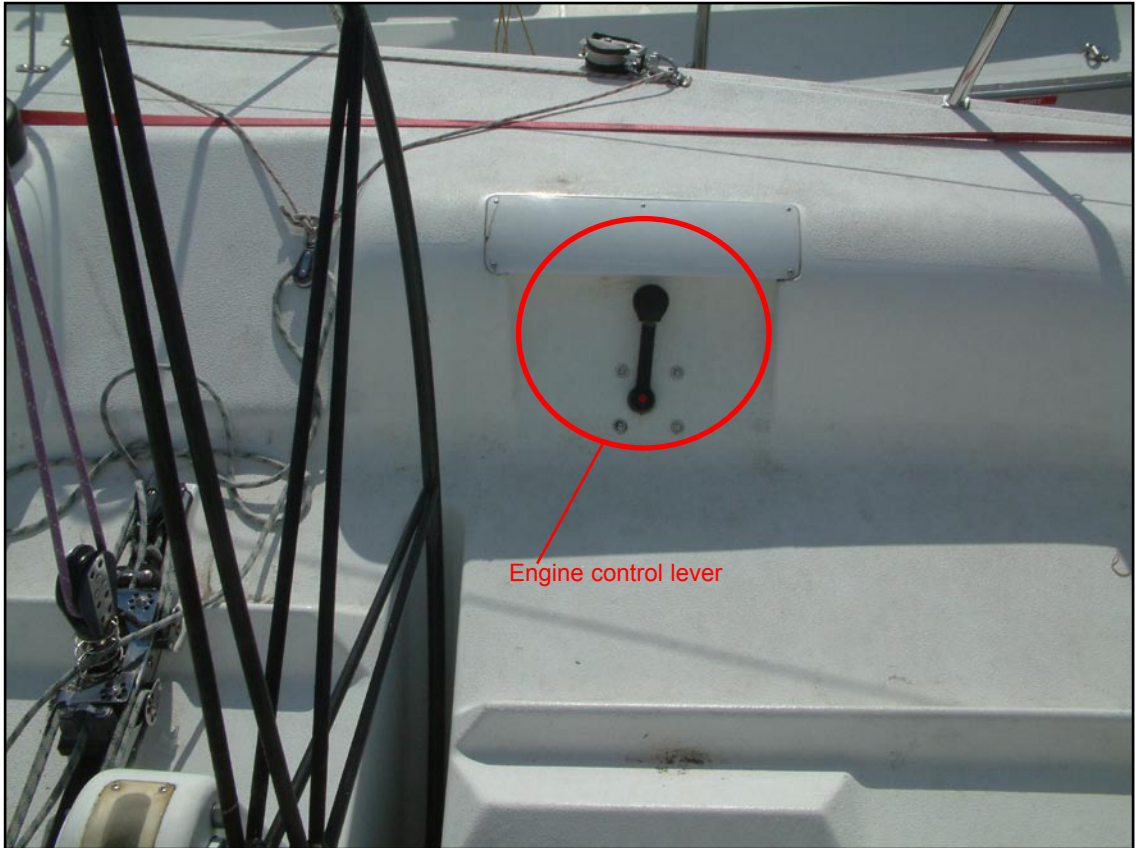
Figure 8

At about 1426, the skipper took the helm from the day skipper and asked him to start the engine. The yacht then tacked back up Southampton Water in preparation for the approach towards the River Hamble. The day skipper unclipped his safety harness and checked that the engine control lever, located at the starboard side of the cockpit (**Figure 8**), was in the neutral position. He found it to be seized, and spent the next 2 minutes releasing it.

Engine control position

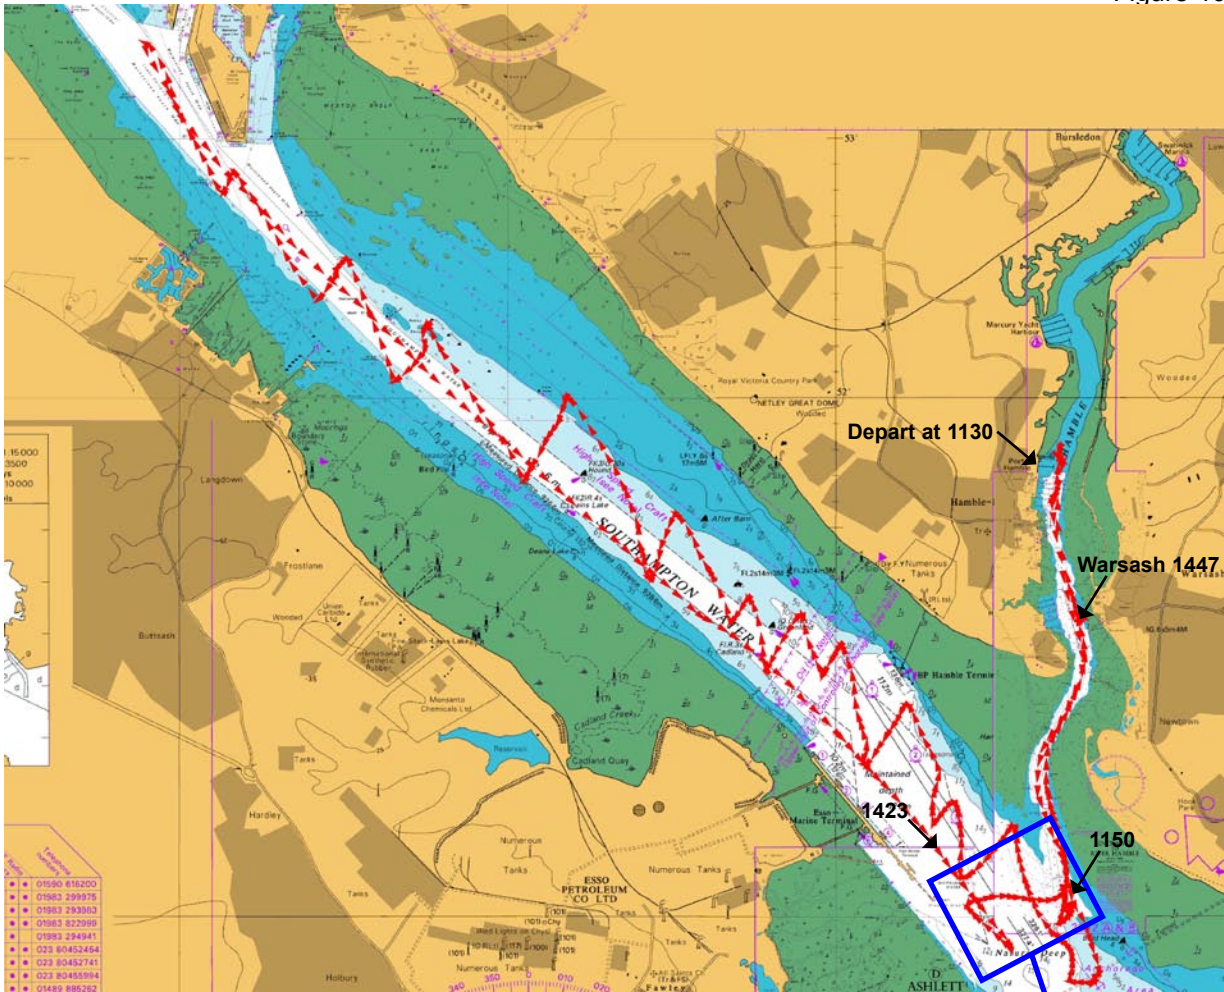
Figure 11

The GPS recorded tracks for the voyage are at **Figure 10**. A detailed GPS track showing the key accident points is at **Figure 11**.

Chart 2036 with superimposed GPS track

The GPS track, at **Figure 11**, shows that the yacht completed her south-easterly run at 1426. At this time, the replacement skipper elected to tack back up Southampton Water. Having moved onto a port tack, he sailed approximately NW for about 2 minutes, before bearing away close to the oil jetties on the west side of Southampton Water. The first accident happened almost immediately afterwards.

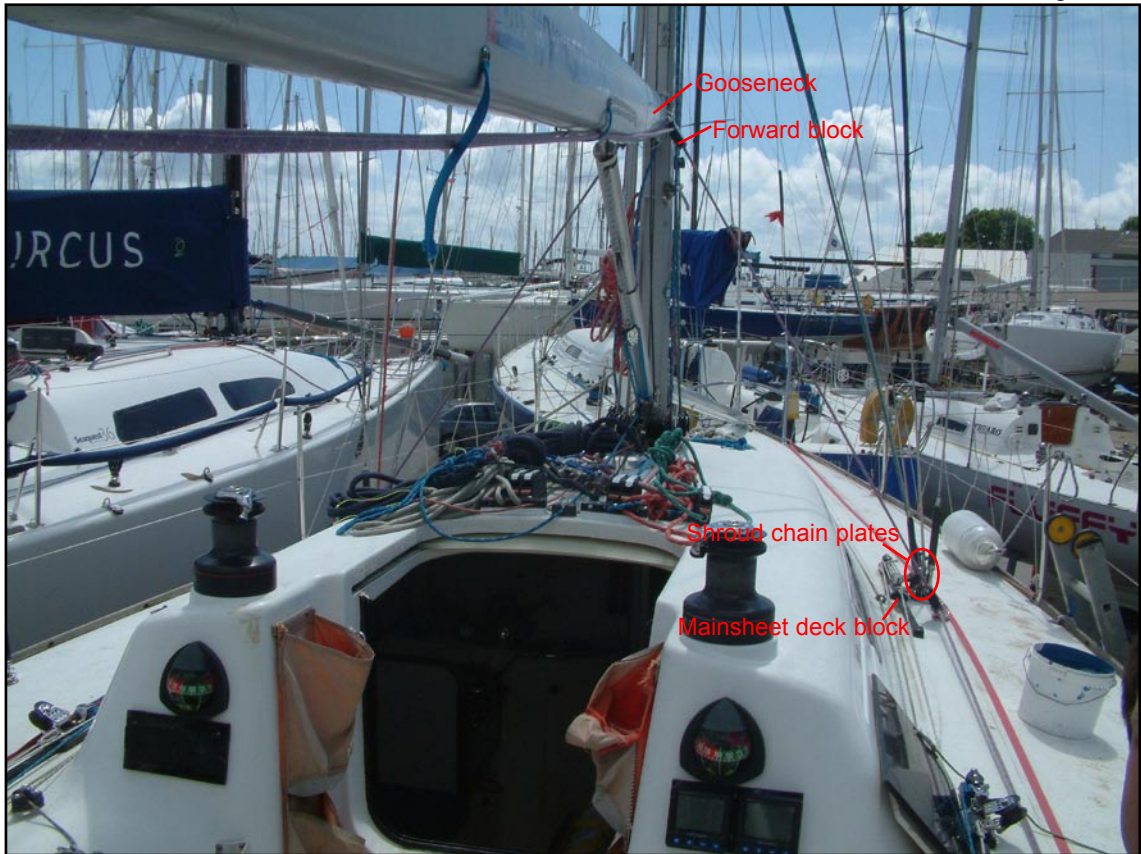
Figure 12

The IMX 38 is fitted with a masthead rig and what is known as a “German” mainsheet system. A conventional traveller positioned forward of the wheel on the cockpit sole has a simple block that leads the main sheet up to a double block at the after end of the low boom. On each side of the boom, these are then led forward to a position just aft of the gooseneck, where they are directed through deck blocks and angled down to the deck to further blocks situated behind the shroud chainplates. The lines then pass aft, to winches mounted on each side of the cockpit. Mainsheet operation and trimming can, therefore, only be carried out using either of the two mainsheet winches. The rigging layout is shown in **Figures 12 and 13**.

Rigging layout - forward perspective

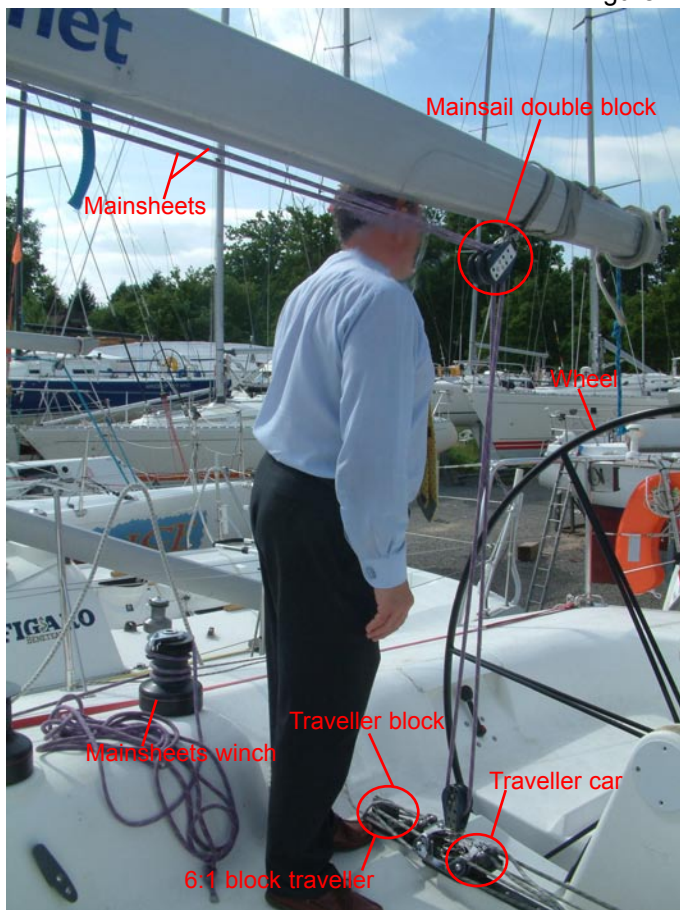
Figure 13

Rigging layout - after perspective
